Manhole Inspection Summary

Manhole # S33KK1030MH

Insp Date: **2/28/07 10:31 AM**

Location Address: **4216 GREENWAY**

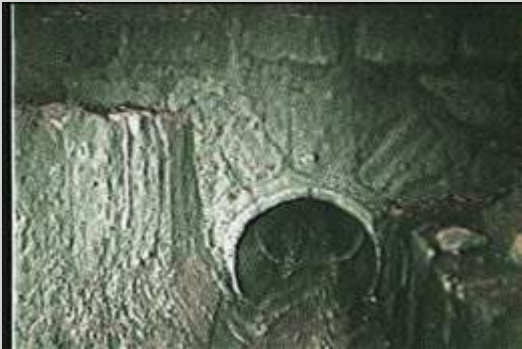
6 in. Circular Gravity Sewer Pipe Out @ 12 O'Clock

Invert Depth: **11.51** (ft.) Flow Characteristics: **Fast**

Infiltration: **None** Pipe Seal Cond: **Unknown**

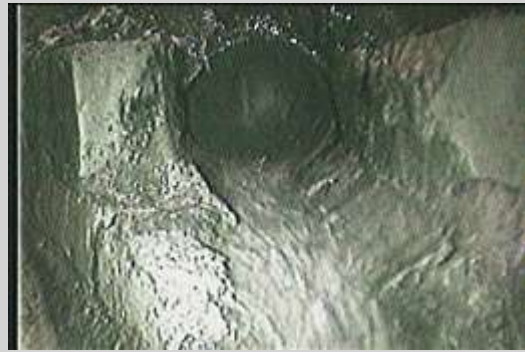
Drop In @ 7 O'Clock

Infiltration: **Evidence** Pipe Seal Cond: **Unknown**

Drop Condition: **Open**
